2 Self-Assessment

2.1 Policy, Practices and Design Standards

2.2 Physical Barrier

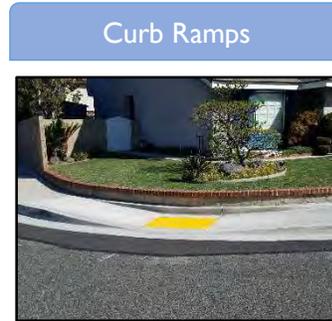
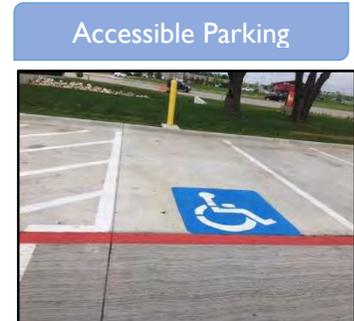
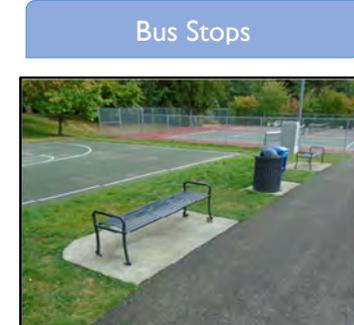
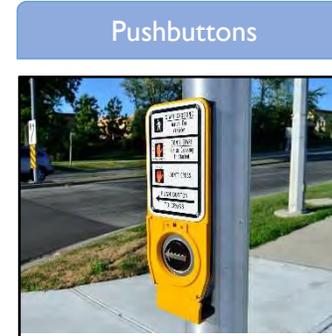
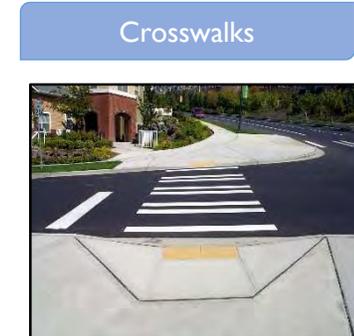
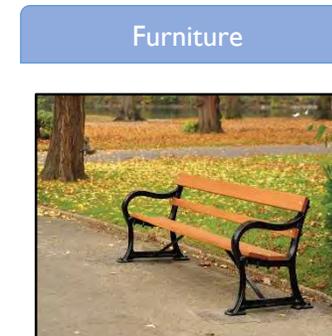
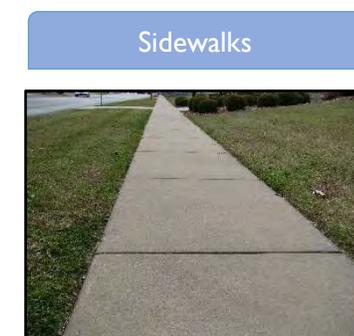
To improve the collection process for curb ramps, an optimization method was developed. The elements of curb ramps that often create

the largest barriers when out of compliance were first measured. If any of these measurements were non-compliant, the data collector stopped taking measurements of other elements on the curb ramp. This method allows

the County to quickly identify which ramps create larger barriers to users and would need to be replaced without collecting data that was deemed irrelevant if the curb ramp needed full replacement. This helped reduce data collection time while still providing the County with accurate data for decision making

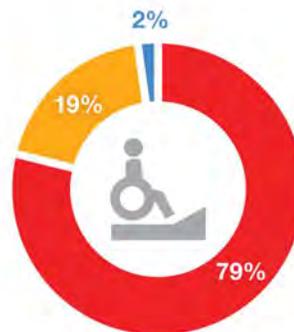
Figure 2-1 Percentage of Major and Minor Non-Compliant Curb Ramps and Compliant Curb Ramps

categories: compliant, minor non-compliant and major non-compliance. A ramp was found to be compliant only if all collected features of the ramp met the required accessibility standards. Both non-compliant categories represent barriers to accessibility that will require attention such as, reconstruction or new ramps. While compliant ramps require no modification. The majority of the existing curb ramps were found to be non-compliant based on current ADA requirements. A ramp was found to be a major non-compliance, if the ramp width was too narrow or if the run or cross slopes were overly steep. A ramp was found to be a minor non-compliance if the barrier was easily removed with maintenance, or if run or cross slopes were only slightly steeper than standard. Figure 2-1 shows a sample of the curb ramps surveyed in the County and the percentage of non-compliant to compliant curb ramps within the County. All non-compliant curb ramps will need to be addressed and all barriers removed, minor and major non-compliances are used to show the level of severity of curb ramp barriers. Compliant, minor non-compliant, and major non-compliant curb ramps are shown in blue, yellow, and red, respectively.

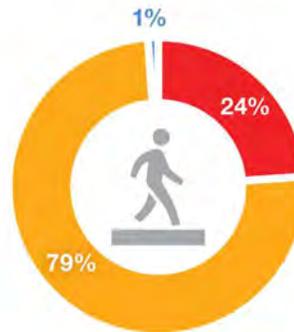
Figure 2-2 Percentage of Major and Minor Non-Compliant Sidewalk and Compliant Sidewalk

Figure 2-2 shows a sample of the sidewalks surveyed in the County and demonstrates the percentage of sidewalk length that is compliant and non-compliant throughout the County. Non-compliant sidewalks are broken into two categories, minor and major non-compliant. For example; a sidewalk is considered to be a major non-compliance if the width is too narrow, or if the cross or run slopes are overly steep. A sidewalk segment with cross or run slopes only

slightly steeper than standard were considered minor non-compliances. All non-compliant sidewalk segments will need to be addressed and all barriers removed, minor and major non-compliances are used to show the level of severity of sidewalk barriers. Compliant, minor non-compliant, and major non-compliant sidewalks are shown in blue, yellow, and red, respectively.
